# Model 1208 - 6 Meter Transverter - PC Board Error

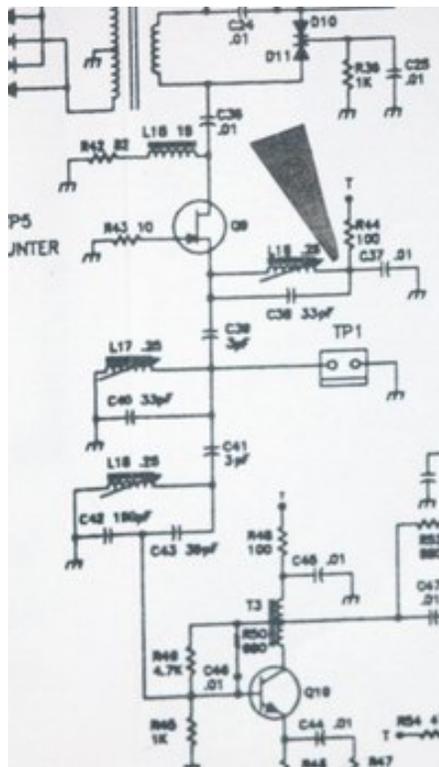
On my board the 3<sup>rd</sup> hole on L16 connected the upper ground plane to a trace on the underside of the board from C37, C38, R44 and L16 effectively taking all these components to ground. A quick review of the schematic shows this is an error.

(The arrow in the figure below shows the portion of the junction grounded by the board fault.)

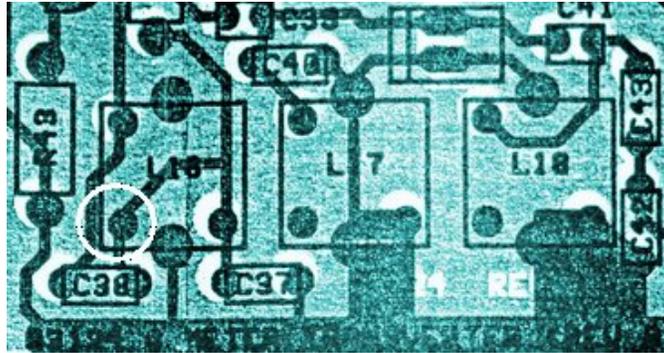
Examination of the X-Ray view shows the problem (see pad inside white circle at lower left of L16). The L17 and L18 pads connect the top ground plane to bottom ground plane BUT L16 connects the top ground plane to a trace on the under side. (Green is component side ground plane, black is underside trace, underside ground plane NOT shown.)
